**SWIMMING POOL REHABILITATION
PROCESS**

REHABILITATION OF A SWIMMING POOL WITH A GLASS MOSAIC FINISH

REHABILITATION OF A SWIMMING POOL WITH A PAINT FINISH

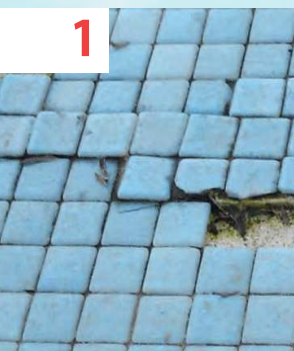
1

Remove the badly adhered pieces.
Glue the loose and weak pieces.

> **B-14 BRICO POOL REPAIRER**

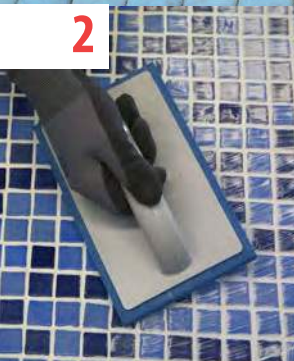
2

Grout the glass mosaic with a special
mortar for swimming pools.

> **CX-23 JUNTADUR UNIVERSAL**

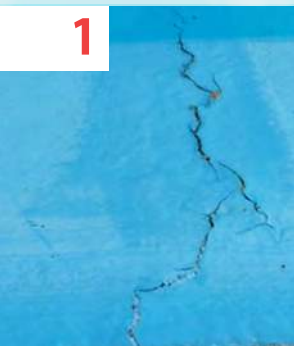
1

Scratch to remove badly adhered parts.
Repair and fill-in cracks fissures, dents
and chips.

> **B-14 BRICO POOL REPAIRER**

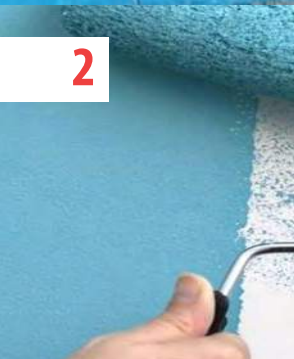
2

Apply a water-based acrylic paint for
decorating and painting of swimming
pools.

> **RX-529 PAINT FOR SWIMMING POOLS**

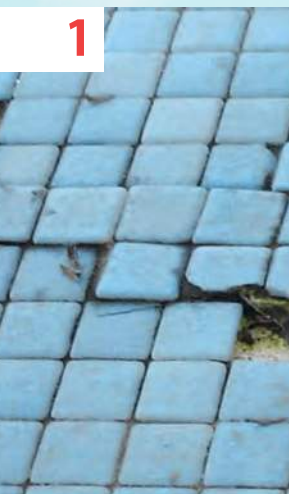
1

GLASS MOSAIC BOTTOM

Sanitize: remove the badly adhered pieces. Fill-in the gaps created due to the lack of pieces.

PAINTED BOTTOM

Sanitize: Scratch to remove badly adhered parts. Repair and fill-in cracks fissures, dents and chips.

> B-14 BRICO POOL REPAIRER

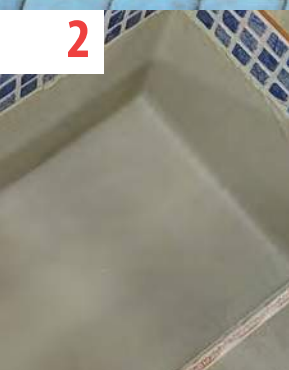
2

Apply a fiberglass reinforced flexible cementitious waterproofing membrane.

> RX-520 SELLADUR FLEX

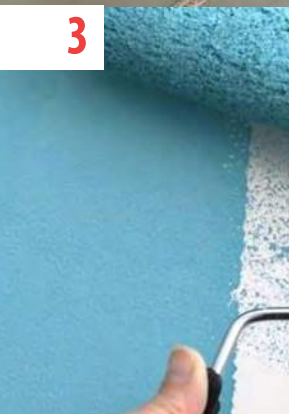
3

Apply a water-based acrylic paint for decorating and painting swimming pools.

> RX-529 PAINT FOR SWIMMING POOLS
